# BETTY CLARK POOL

## *Repairs and Renovations Update*

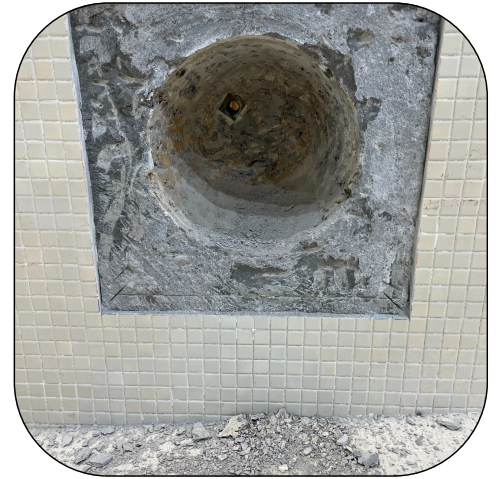
### POOL LIGHTS

This first picture shows an example of the removal of a pool light, six in all. The lights in the pool were all leaking, though they were not the source of the leaking that closed the pool. They didn't and wouldn't offer greater visibility for the lifeguards to protect the pool, especially with the upgraded ceiling lighting, so the spaces will be filled in, and the surface retiled.

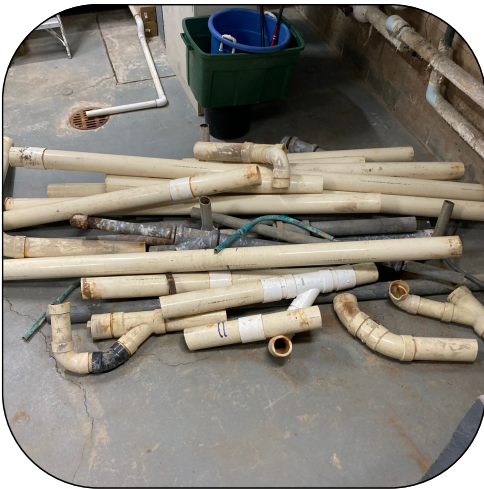
### PIPING

Here you see hundreds of feet of old pool piping that either went from the pool's gutters to the pool pump room for filtering and chlorination purposes, or were remnants of the pool deck drains structure. All of this piping is being replaced. The piping that returns the filtered and chlorinated water from the pump room to the pool was replaced in 2020, and still in good shape.

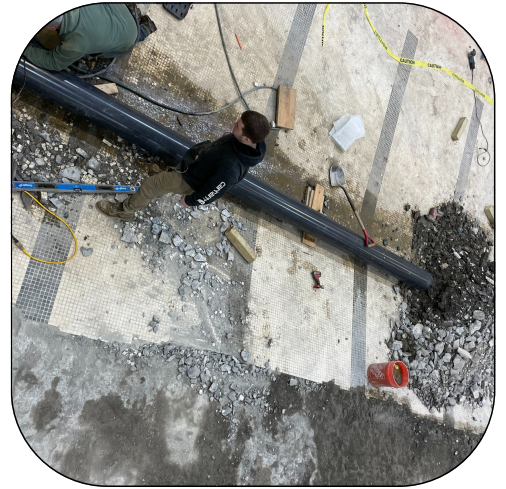
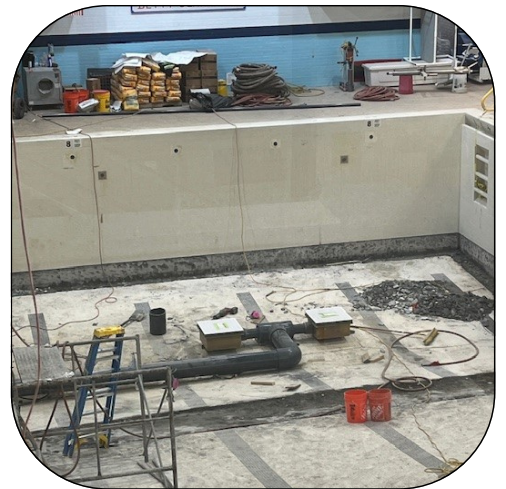
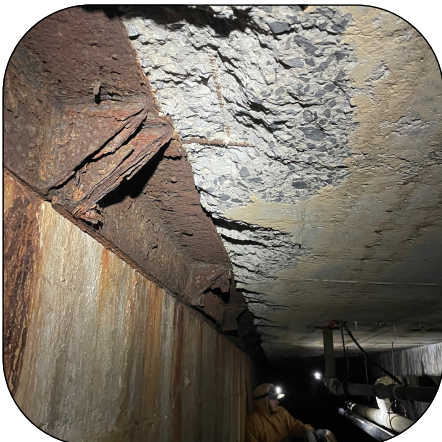
## MAIN DRAIN

For the next area of work, we have two pictures. The first is of the new main drain pipe that takes most of the water back to the pool pump room. This was the source of the sustained leaking that closed the pool, and a simple repair, were it even possible was not the answer. The single, original side wall main drain was out of compliance with Federal regulations circa 2008. The second picture is of that main drain attached to the two new bottom drains that will recycle water.

In the main drain pictures, you see them sit on the bottom of the deep end of the pool. Tile has been removed from the edges, and where the bottom meets the beginning of the upward slope. The tile itself will be covered by stone crush to keep the main drains in place and provide for greater adhesion when the concrete is poured to form the new deep end bottom that will sit at seven feet below the water's surface.

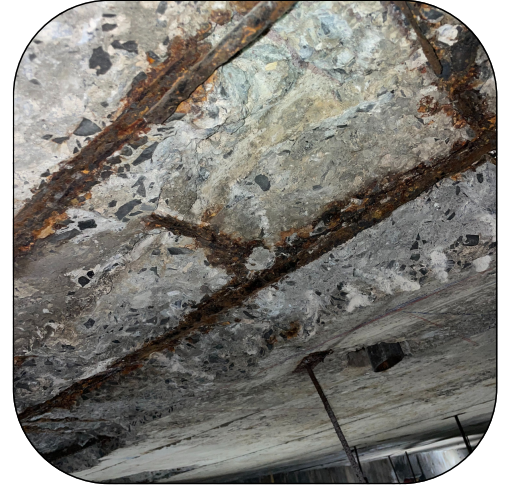
## SUPPORT BEAMS

The picture here is of one of the two structural steel braces that support the pool deck from below and will be replaced. You see the corrosion of the beam itself and also the pitting of the underside of the pool deck.
